# Manhole Inspection Summary

Manhole # S51K\_\_036MH

Insp Date: **3/31/08 12:13 PM**

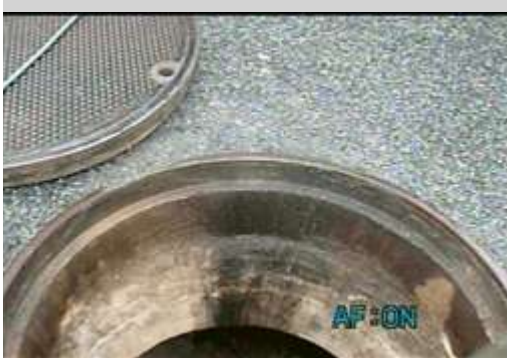
Defect 2

**Frame** Offset: **0** (in.) Condition: ☐ Sound ☐ Cracked ☒ **Leaks**

infiltration at street level

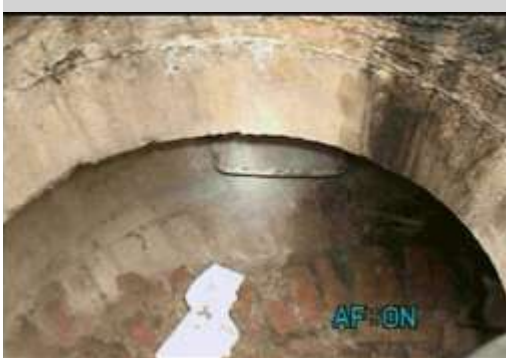
Defect 1

**Steps** Count: **1** Missing: **0** ☒ **Corroded**

step

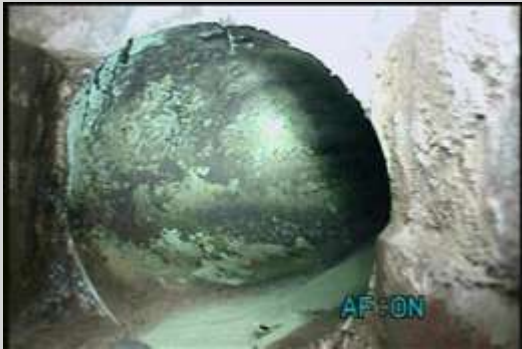
12 O'Clock Outflow

8 in. Circular Gravity Sewer  
Pipe Out @ 12 O'Clock

Pipe Material: PVC ☐ Pipe Lined

Invert Depth: 4.46 (ft.) Flow Characteristics: Fast

Infiltration: None Pipe Seal Cond: Unknown

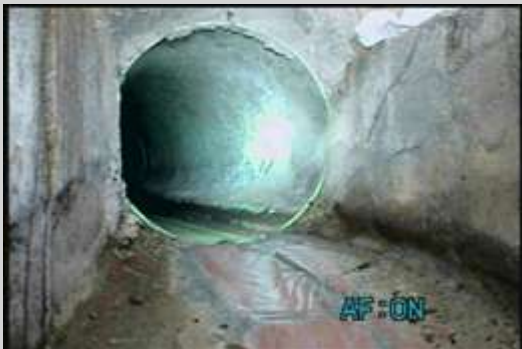
3 O'Clock Inflow

8 in. Circular Gravity Sewer  
Pipe In @ 3 O'Clock

Pipe Material: PVC ☐ Pipe Lined

Invert Depth: 4.30 (ft.) Flow Characteristics: Fast

Infiltration: None Pipe Seal Cond: Unknown
